## ILLINOIS ENVIRONMENTAL PROTECTION AGENCY

To: Division file 1150150053/Macon  
Midland Machine  
S. F. Technical

Subject: Site Visit

PHOTOS TAKEN ON APRIL 27, 1999 AT MIDLAND MACHINE  
by Julia Carter

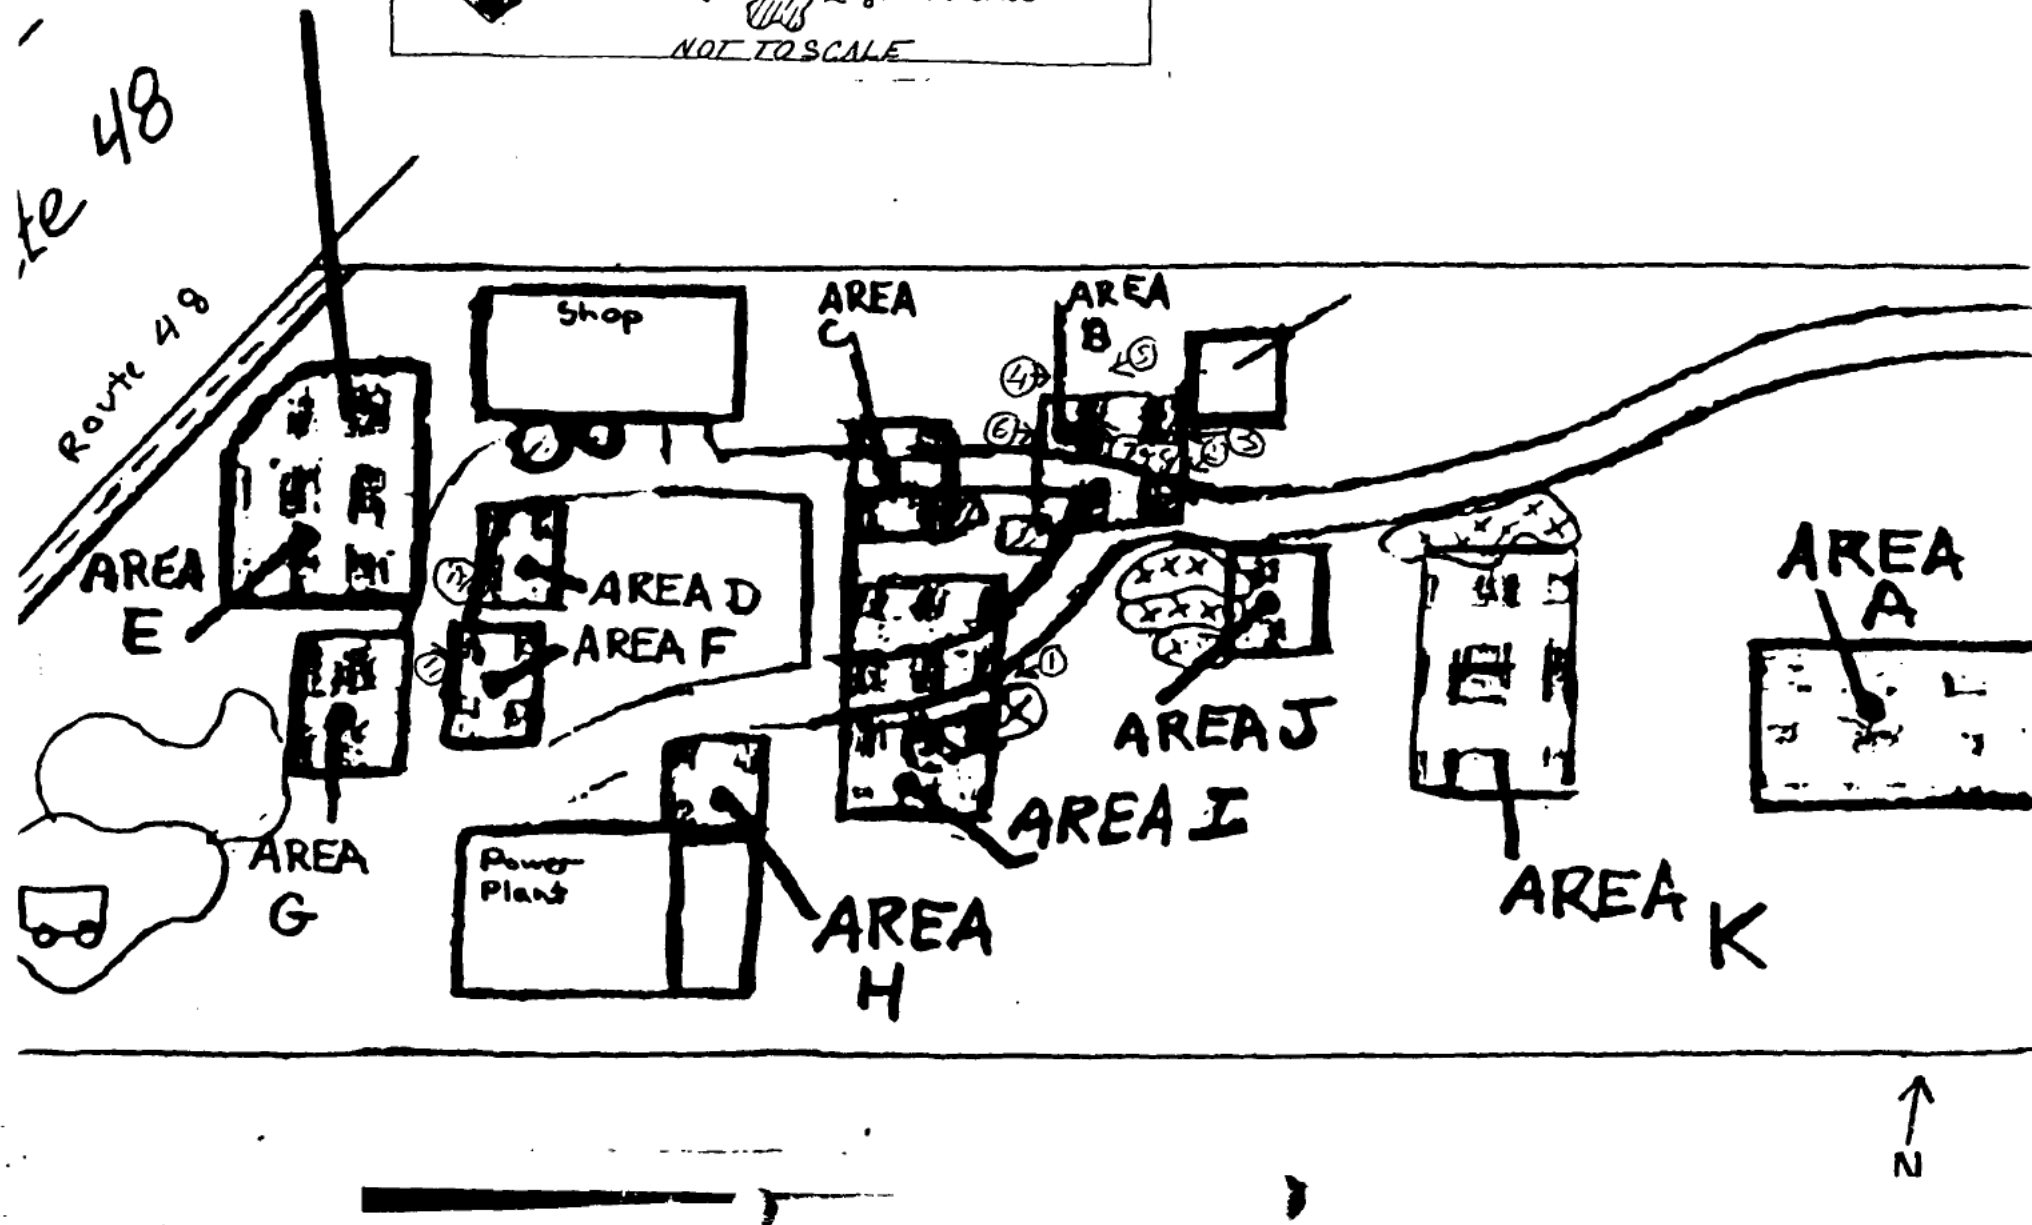
It was difficult to make an accurate count, but there were approximately 130 drums in the area. Most of the drums had been over packed, but some had not. Most of the over packs were rusty and some drums were bulging or had tipped over. Portions of the staging area were underlain with a tarp or plastic sheeting which appeared to be saturated with oily material. Oily material had drained away from the staging area and killed vegetation in some areas. Several photos of the drums are attached to this memo.

All photos on this page were taken of the area identified as Area A on the attached map.

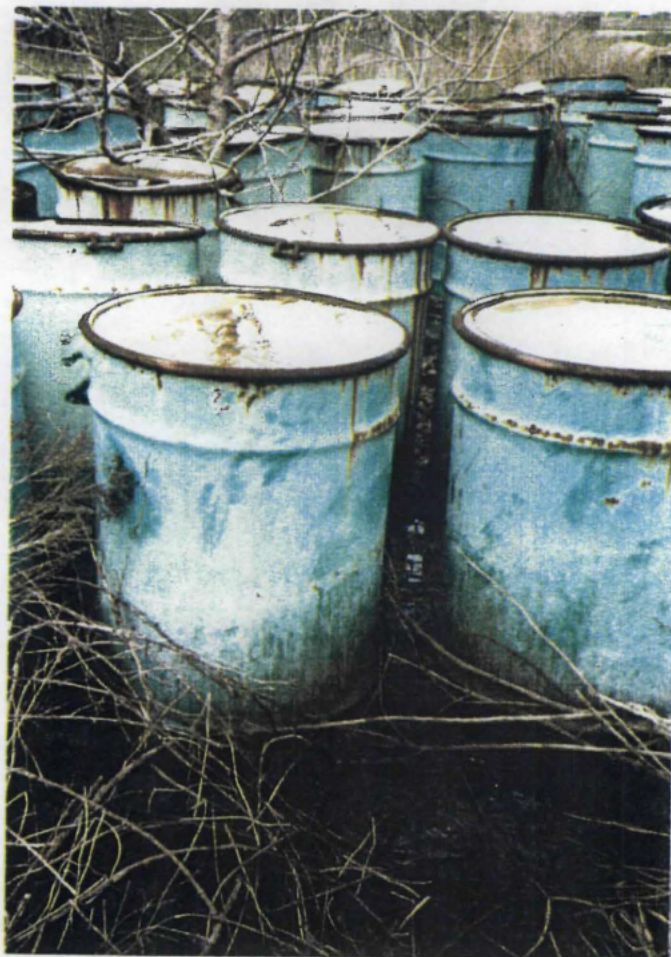
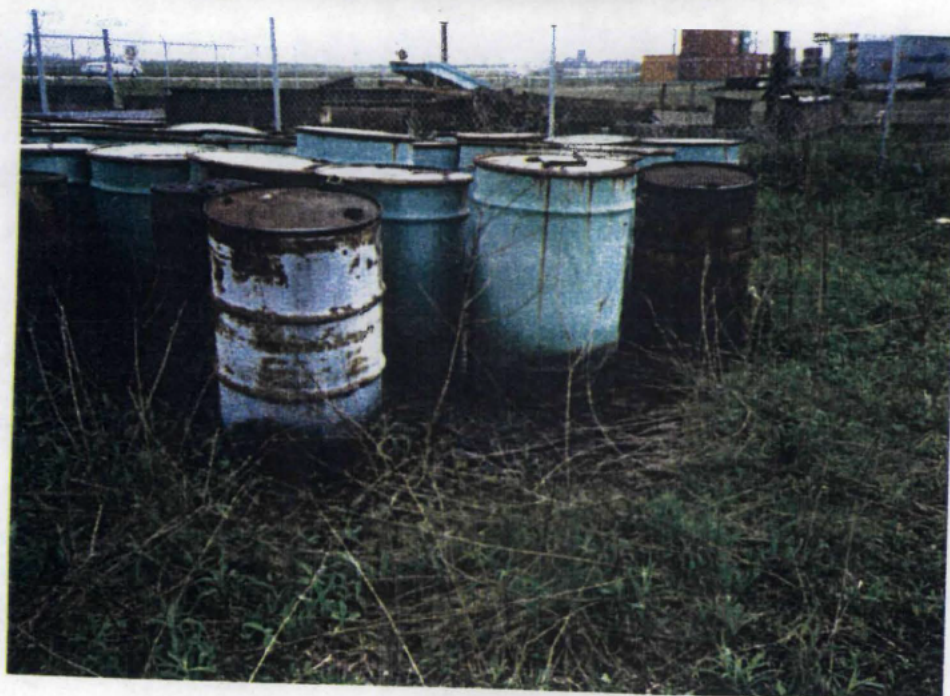
PHOTOS TAKEN ON APRIL 27, 1999 AT MIDLAND MACHINE  
by Julia Carter

All photos on this page were taken of the area identified as Area A on the attached map.

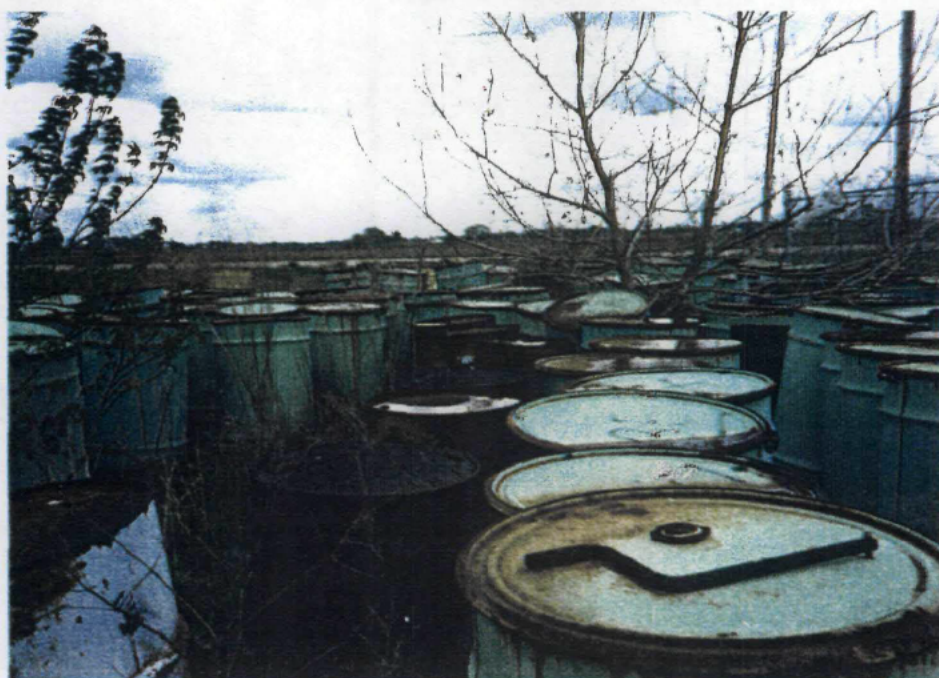
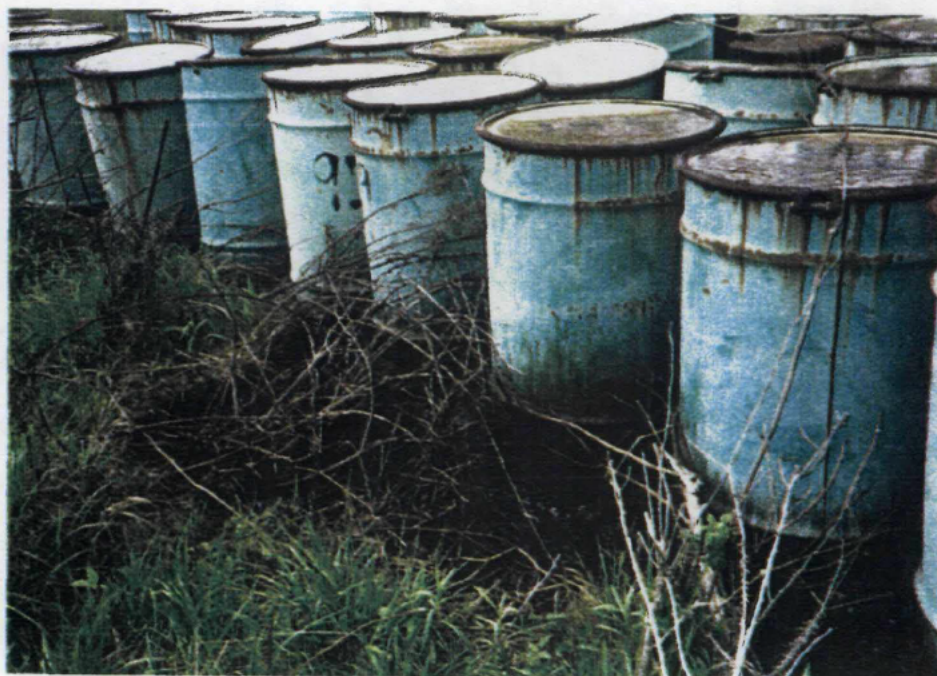
PHOTOS TAKEN ON APRIL 27, 1999 AT MIDLAND MACHINE  
by Julia Carter

All photos on this page were taken of the area identified as Area A on the attached map.

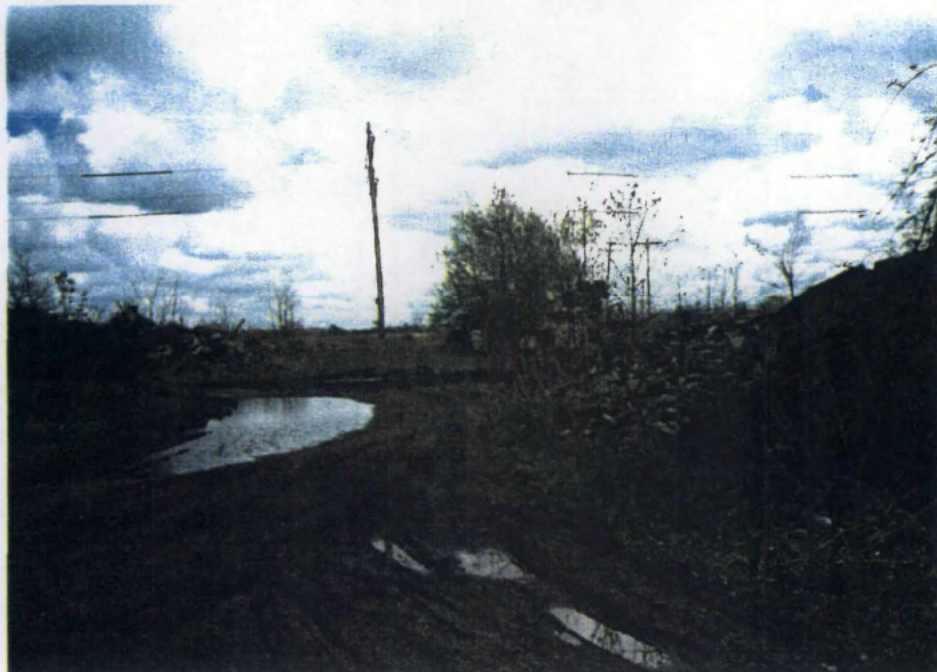
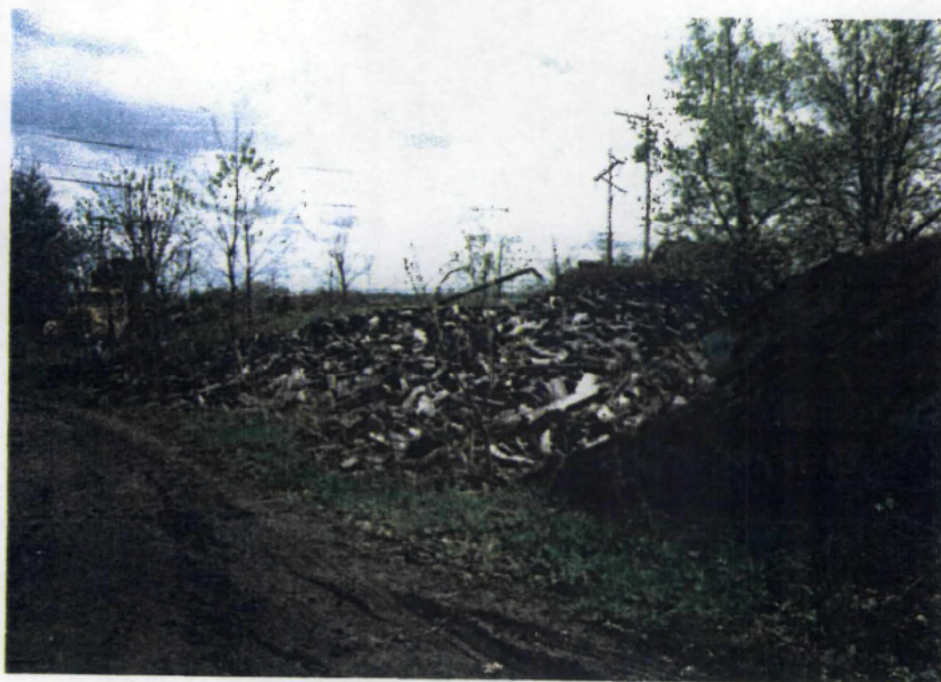
PHOTOS TAKEN ON APRIL 27, 1999 AT MIDLAND MACHINE  
by Julia Carter

All photos on this page were taken between Area A and the shop as shown on the attached map.

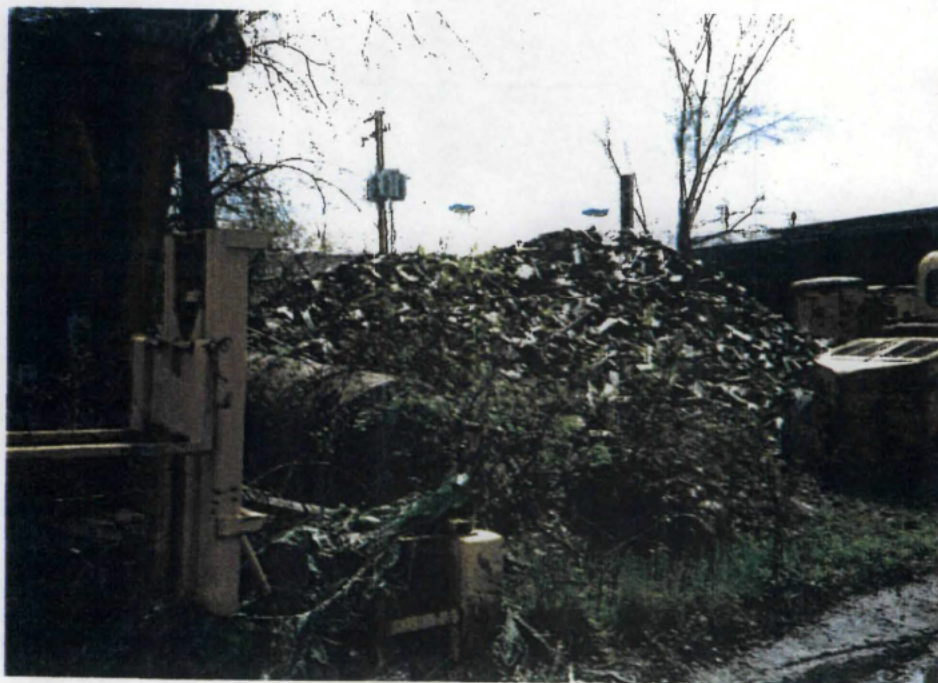
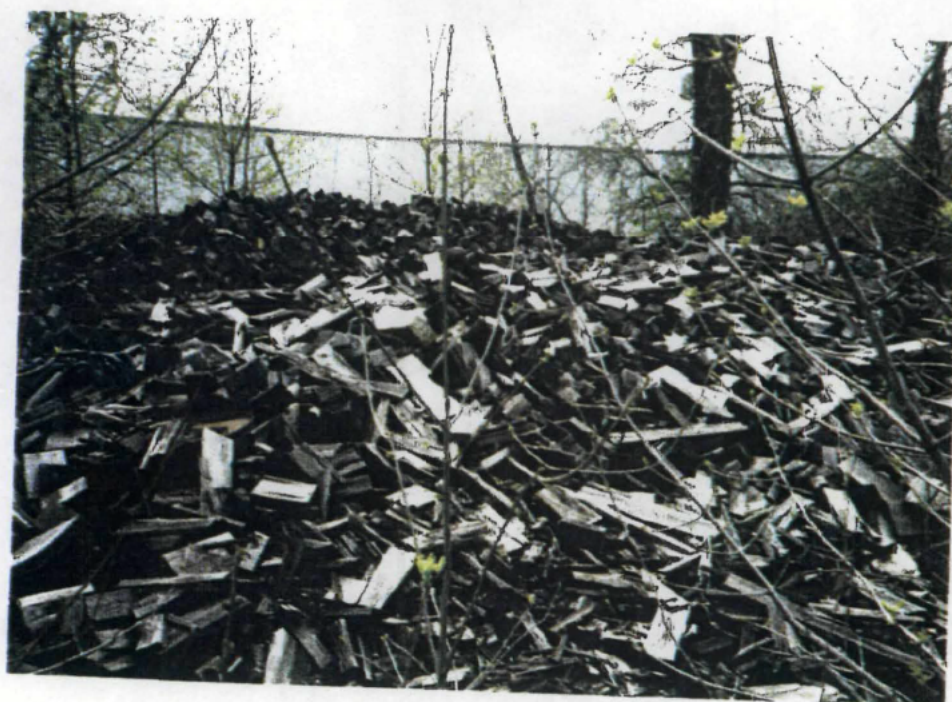
PHOTOS TAKEN ON APRIL 27, 1999 AT MIDLAND MACHINE  
by Julia Carter

All photos on this page were taken between Area A and the shop as shown on the attached map.

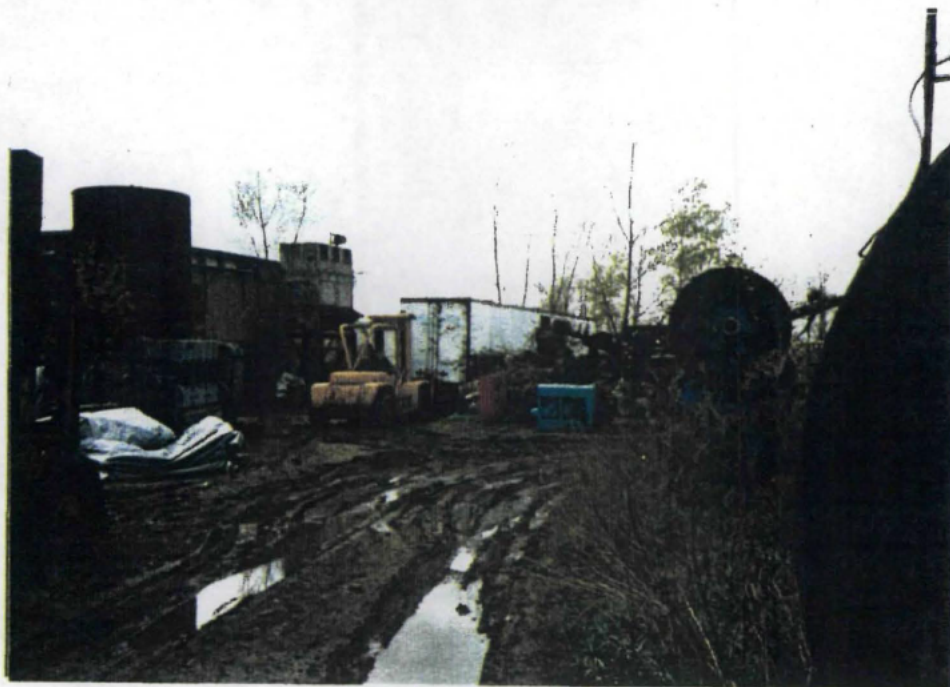
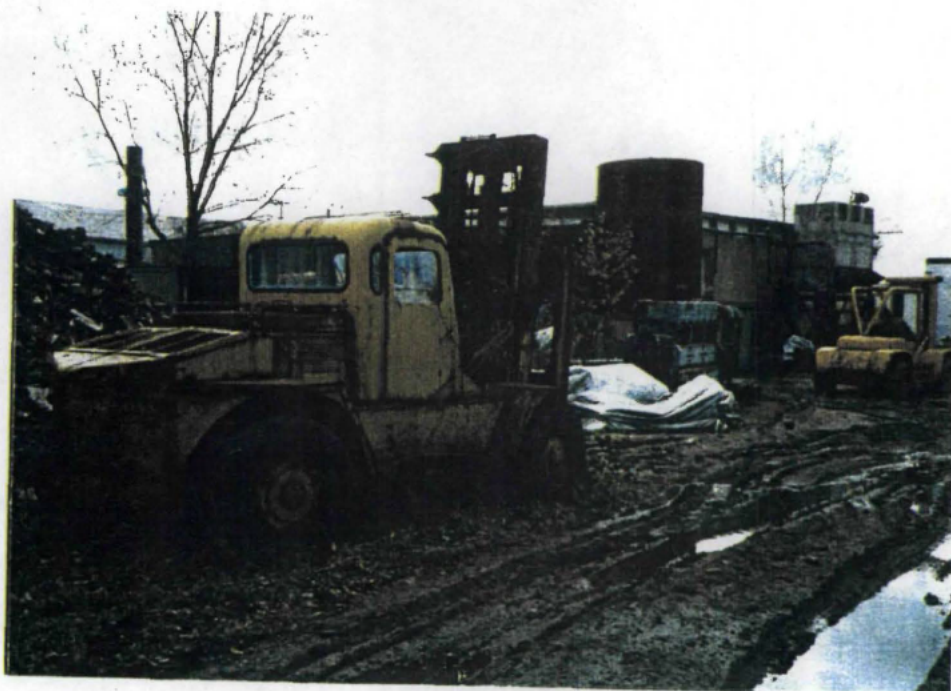
PHOTOS TAKEN ON APRIL 27, 1999 AT MIDLAND MACHINE  
by Julia Carter

All photos on this page were taken between Area A and the shop as shown on the attached map.
